# A RESEARCH STUDY ON INTERNAL CORROSION OF HIGH PRESSURE BOILERS

# FINAL PROGRESS REPORT

# P. GOLDSTEIN

Steam and Water Division
Kreisinger Development Laboratory
Combustion Engineering, Inc.
Windsor, Connecticut

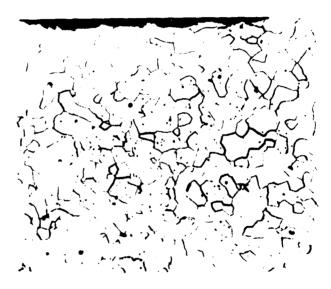
Initial metallurgical examination revealed some surface decarburization in localized areas. In order to ascertain the significance of the decarburization, it was decided to examine the ductility of the material. It was felt that such a test would indicate whether or not incipient hydrogen damage was present. Tensile test specimens were prepared from sections of the heated and unheated sides of the tubing. The specimens were pulled to failure and sections were removed for metallurgical examination. As shown by Fig. 25, no fissuring was present nor loss of ductility experienced.

Fig. 25: Upper—250X photomicrograph of test section tube metal after Test 2C

Lower —100X photomicrograph of test section tube metal after tensile test.
